Investigation of Crystalline Products in Cored Concrete Sample

Reported to: Xypex Chemical Corporation

Examination Period: June 2017 - August 2017

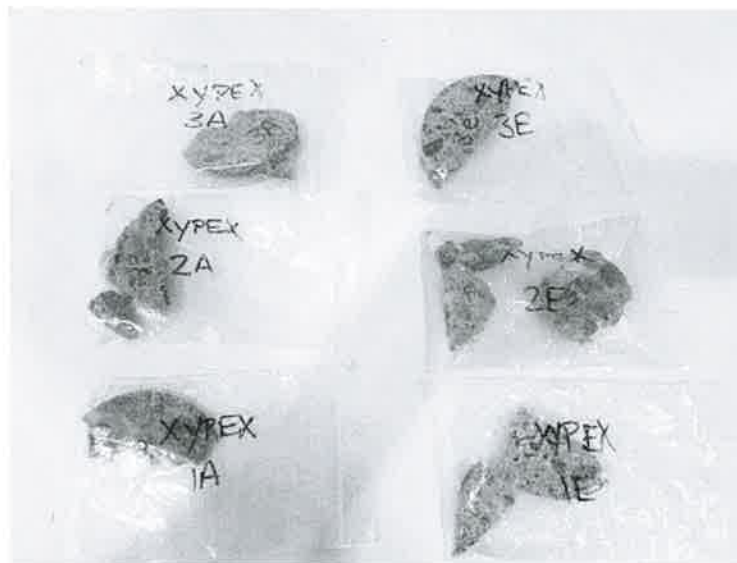
Figure 1: As-received samples for crystal investigation.

Three cored concrete sample were obtained from the abutment of Breidbalakvisl Bridge in Iceland. The abutment was treated with Xypex Concentrate in 1993. The core samples are named "1", "2", and "3". Each core was cut into slices. The portion of each core in the distance within 8 mm from the surface is denoted by "A" (namely 1A, 2A, 3A) while the portion in the distance between 150 – 165 mm is denoted by "E" (namely 1E, 2E, 3E). These six slices were selected for the investigation. **Figure 1** shows the samples as received.

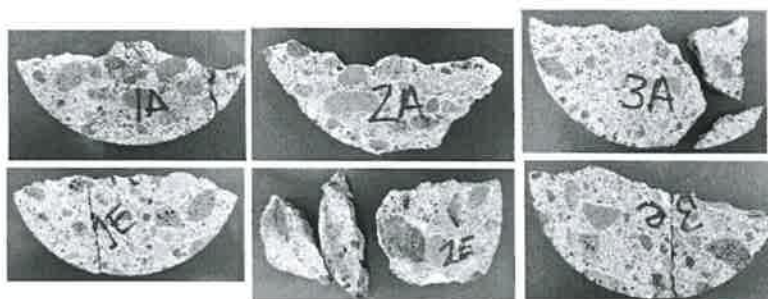
(a) Six different core samples

The surface slices (1A, 2A, and 3A as shown in Figure 2a) and three slices from deeper portion of each core 1E, 2E, and 3E (as shown in Figure 2a) were broken into smaller pieces with an approximate size of 5 mm.

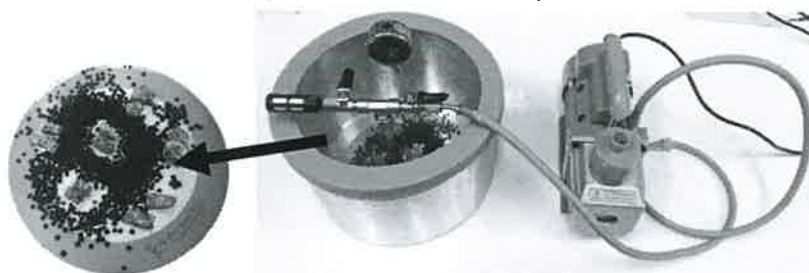
(b) Drying of specimens using by silica gel and removing air and humidity by vacuum impregnation

Two small pieces were selected from each slice to be investigated for presence of crystalline products. These small pieces of samples were then kept in vacuum chamber with silica gel (as shown in Figure 2b) for 3 days in order to dry the sample. The sample were then coated by gold spraying (as shown in Figure 2c) just before performing the investigation using SEM.

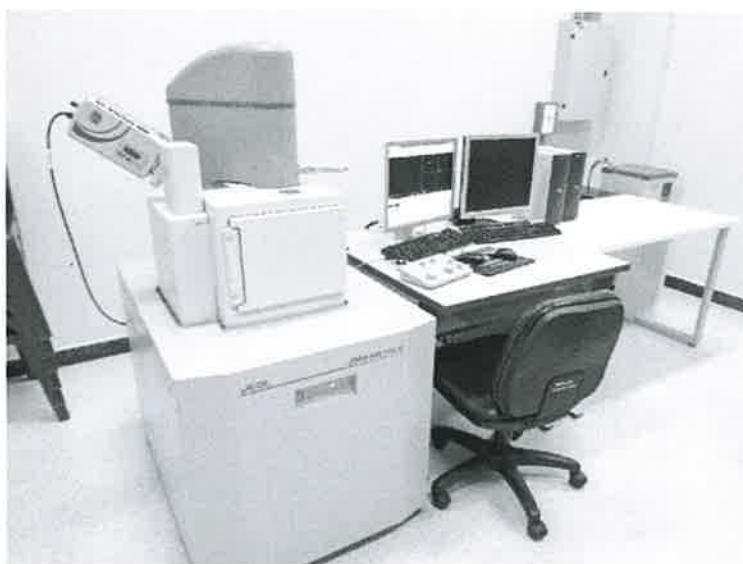
Figure 3: SEM/EDX machine used in this investigation

The coated sample were inserted into the SEM/EDX machine (JEOL JSM-6610LV) shown in Figure 3. Surface morphology of each sample were then observed thoroughly. The SEM photos were then taken at five different locations in each sample in order to represent the overall morphology found in each sample. At each location, photos with three different magnification levels (200x, 1000x, 5000x) were taken for references.

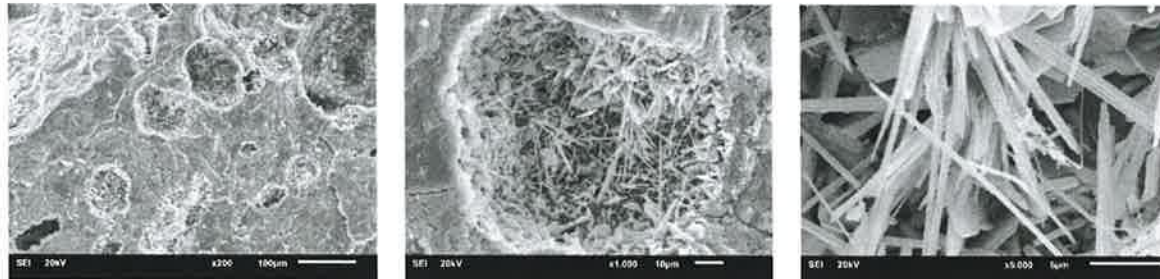
Figure 4: Example of SEM photos (Sample 1A -1 at the 3rd location)

The examples of SEM photos (Sample 1A-1, 1A-2, 3A-1, 3E-1) are shown in **Figure 4**, **Figure 5**, **Figure 6**, and **Figure 7**.

Core ID	Near-Surface Sample (A) (within 8 mm from surface)		Sample from Deeper Portion (E) (approximately 150 mm from surface)	
1	1A-1	A lot of crystal found. Most (90%) of the crystal is needle-like with few crystal in the different forms	1E-1	There is noticeable needle-like crystal but the formation intensity is much lower than "1A-1". However, existence of small crystal is extensively noticeable on surface.
	1A-2	A lot of hexagonal plate-like crystals with few needle-like crystal.	1E-2	Not so much crystal found throughout the investigation on this sample.
2	2A-1	A lot of crystal found. The characteristics and shapes of crystal also vary a lot.	2E-1	Not so many clear crystal is observable. However, some products obviously formed on the surface of voids.
	2A-2	A lot of crystal found. Most of voids are filled with crystals. However, it was observed that, in some voids, the crystal could not fully developed.	2E-2	Crystal extensively forms on the surface of air bubble. However, shapes and characteristics of the crystal varies a lot. Many shape of small crystal found

The high variation of the crystal found in this investigation should be also emphasized. For near-surface samples, the sample "1A" show approximately 90% of needle-like crystal with the rest as plate-like hexagonal crystal. The sample "2A" show several forms of crystals including needles, sheet, and sphere, etc. While, the sample "3A" show plenty of small hexagonal crystals and sphere products with very little of needle-like crystal. Similarly high variation of crystal is found in the case of samples from deeper portion (1E, 2E, and 3E).

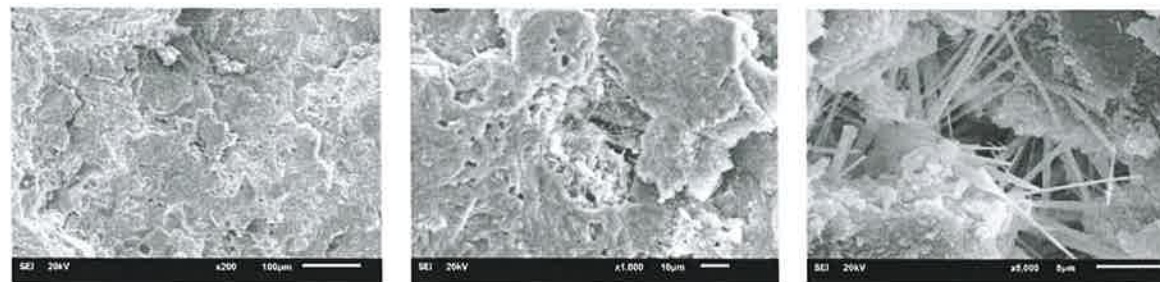
Figure 6: Example of SEM photos (Sample 3A -1 at the 4th location)

3	3A-1	Not so much large crystal found although many small hexagonal crystals could be observed at the surface of air bubble. Some small size air voids are filled with needle-like crystals.	3E-1	Considerable amount of needle-like crystal or hexagonal plate-like crystal found. However, it seems that the crystal could not fully develop in some voids. Denser crystal development is found in smaller voids. (More crystal found than in 1E-1)
	3A-2	Not so much large crystal found. Some substance is observed on the surface of voids but the shape of crystal is unclear.	3E-2	Very strange shape of crystal is found. The crystal seems to be distributed well on the surface of void. However, the amount of crystal is not so much.
